**Phase I Archaeological Survey
of the Bangor Hydroelectric Company (BHE)
Northeast Reliability Interconnect Project
Orrington to the St. Croix River,
Penobscot, Hancock, and Washington Counties, Maine**

December 23, 2004

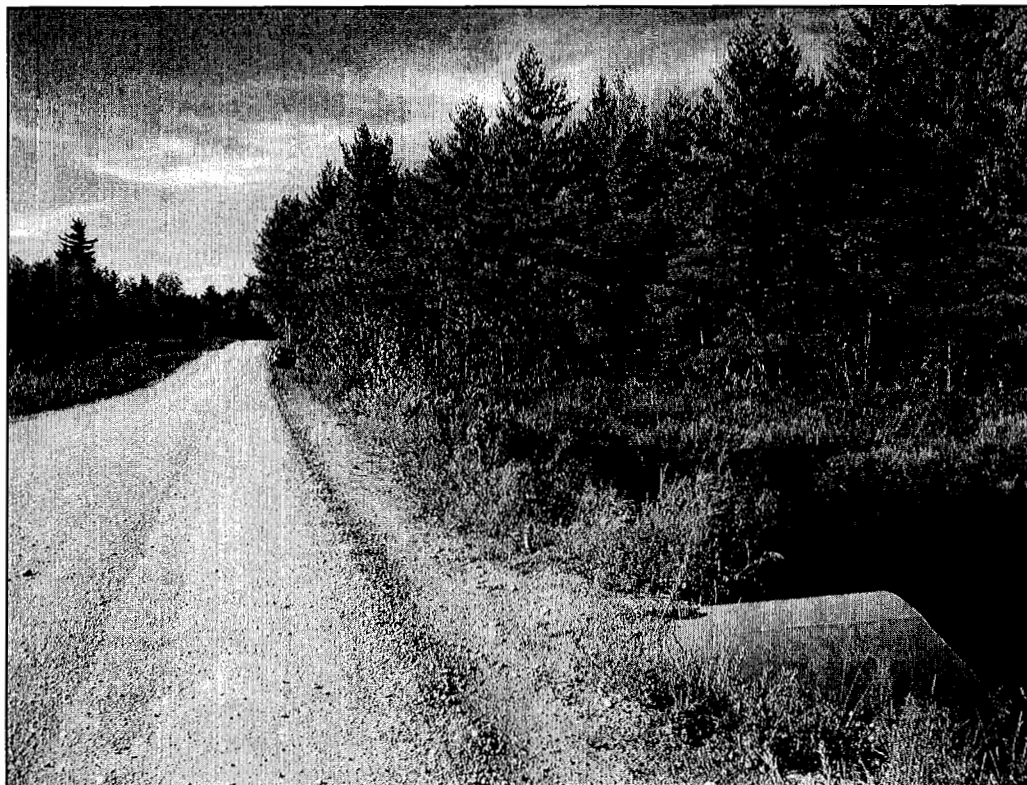
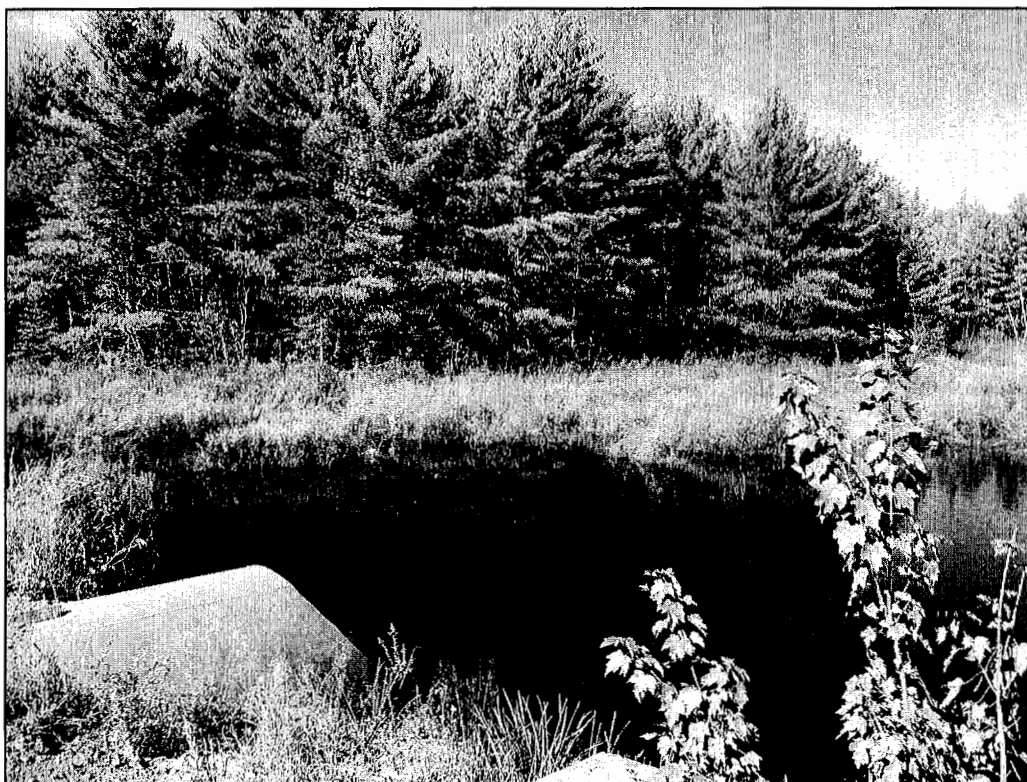
Figure 1.1. Testing Area 1 –Dead Stream west side—showing the location of archaeological testholes superimposed on USGS 7.5 minute topographic map (above) and aerial imagery (below). Approximate scale is indicated. Transmission line route (approximate) is shown as a dashed white line. Testhole locations are shown as filled x's and reflect corrected GPS coordinates taken in the field. *Image source: U.S.G.S. 1:24,000 and 1:12,000 The Horseback, Maine, quadrangles.*

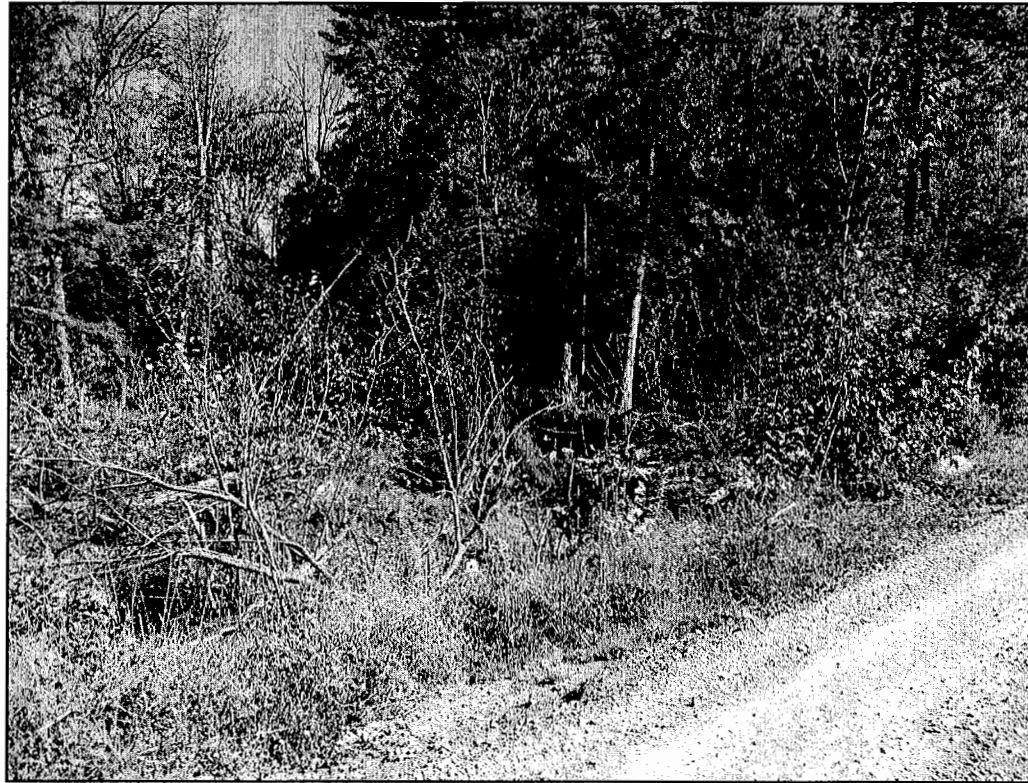
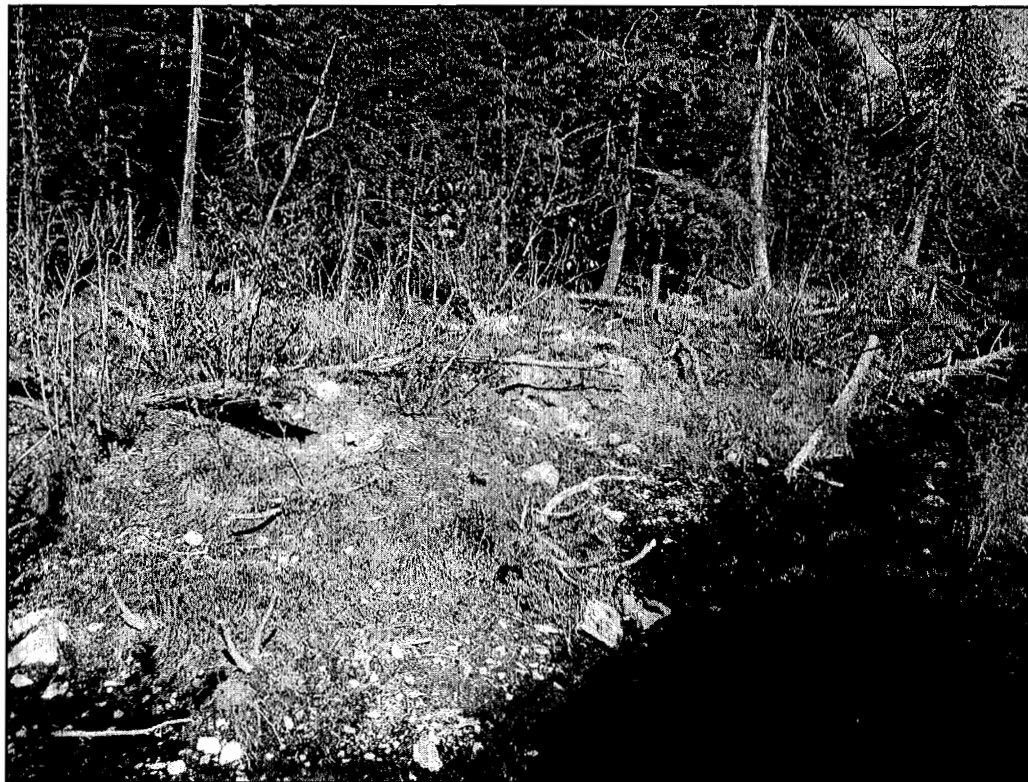
Figure 2.1. Testing Area 2—Hinckley Brook west side—showing the location of archaeological testholes superimposed on USGS 7.5 minute topographic map (above) and aerial imagery (below). Approximate scale is indicated. Transmission line route (approximate) is shown as a dashed white line. Testhole locations are shown as filled x's and reflect corrected GPS coordinates taken in the field. *Image source: U.S.G.S. 1:24,000 and 1:12,000 Great Pond, Maine quadrangles.*

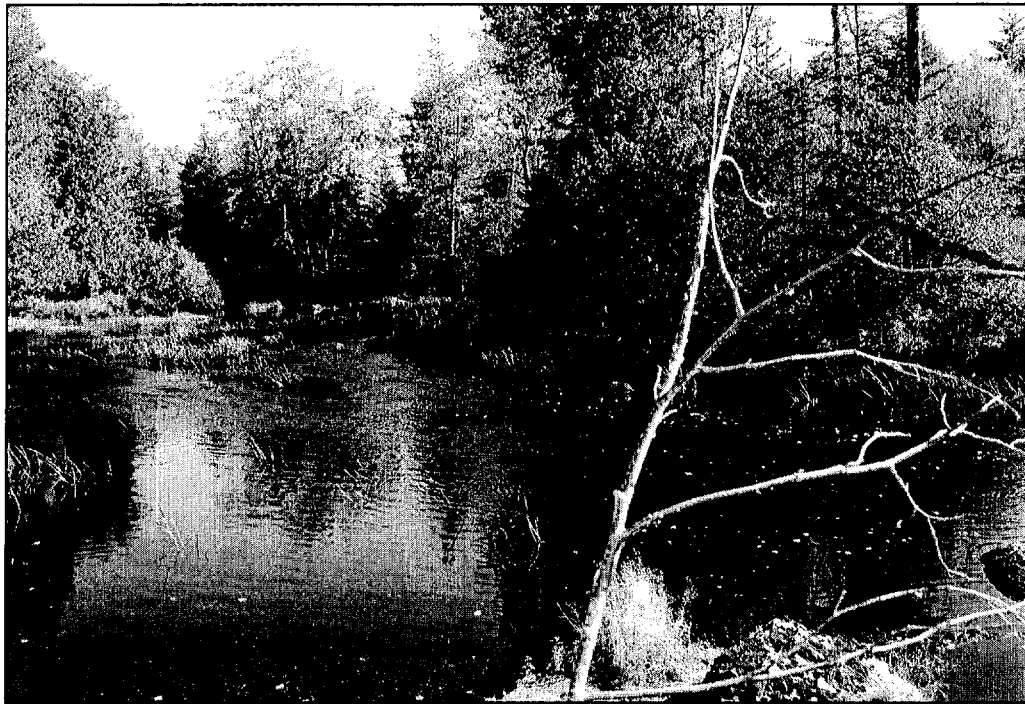
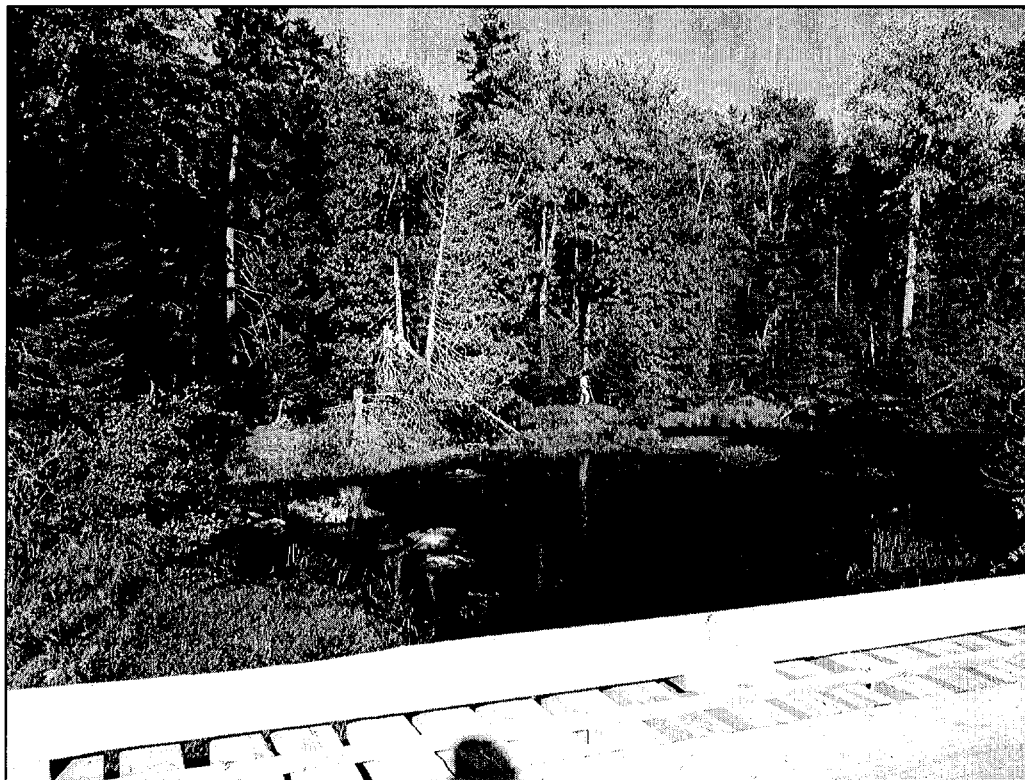
Figure 3.1. Testing Area 3 –Main Stream—showing the location of archaeological testholes superimposed on USGS 7.5 minute topographic map (above) and aerial imagery (below). Approximate scale is indicated. Transmission line route (approximate) is shown as a dashed white line. Testhole locations are shown as filled x's and reflect corrected GPS coordinates taken in the field. *Image source: U.S.G.S. 1:24,000 and 1:12,000 Great Pond, Maine quadrangles.*

Testing area 3. Testing area 3 is located along both the east (TA3E) and west (TA3W) banks of Main Stream. The Project crosses Main Stream in Great Pond (Plantation 33), Hancock, County, Maine (Figure 3.1). The approximate geographic center of the area sampled can be located on the U.S.G.S. 7-1/2 minute (1:24,000 scale) topographic series, Great Pond, Maine quadrangle at UTM coordinates Z19N4981489E555420 (NAD 27 meters) and Maine State Plane coordinates N481588E1023628 (Zone Maine East 1801-NAD 83- feet).

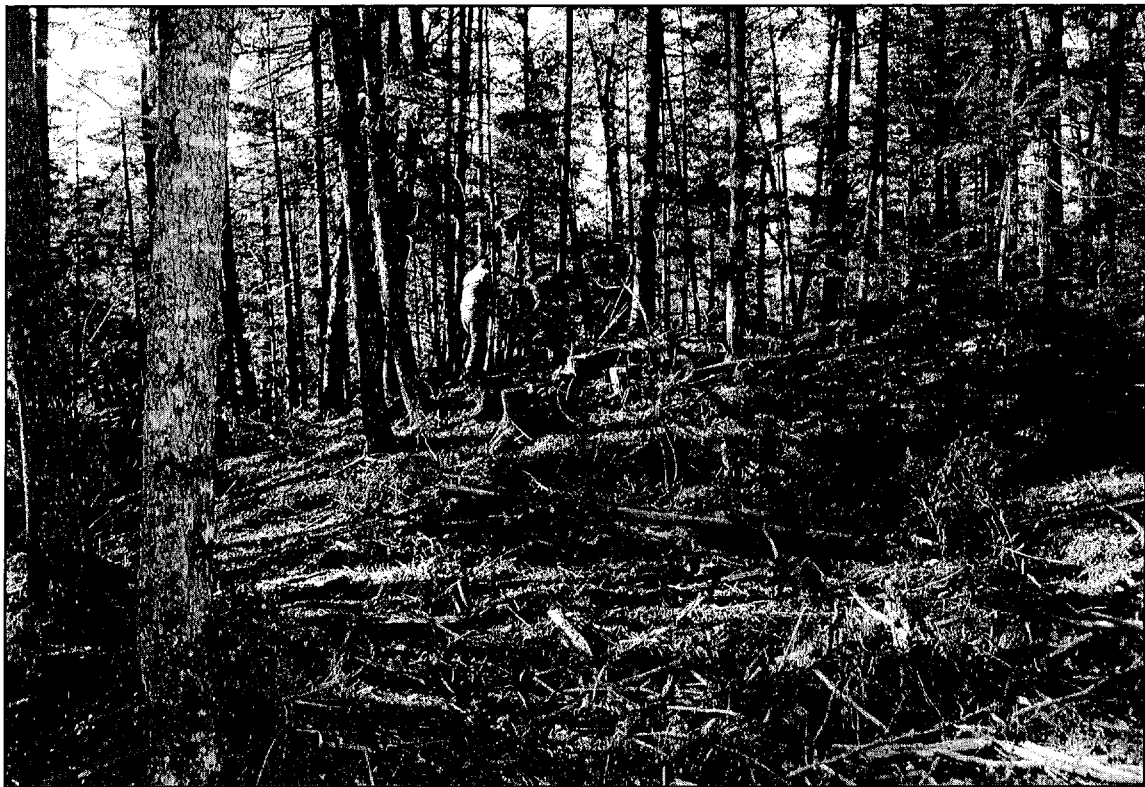
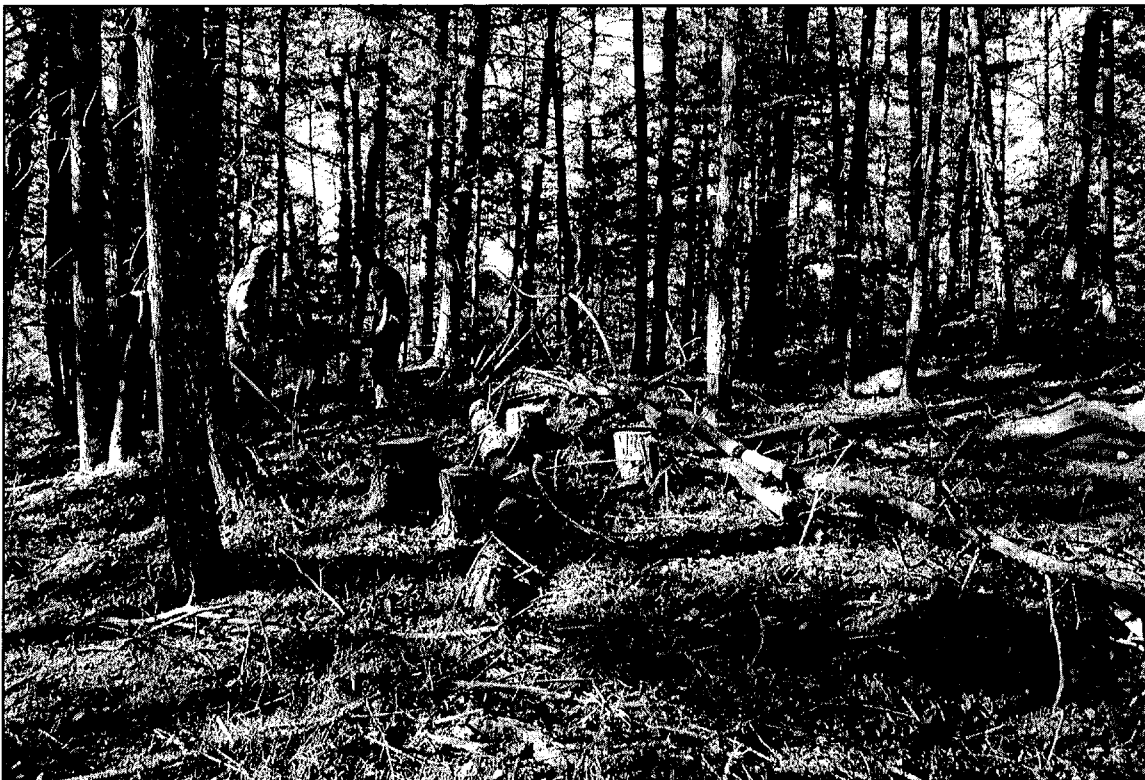
Figure 4.1. Testing Area 4—Alligator Stream—showing the location of archaeological testholes superimposed on USGS 7.5 minute topographic map (above) and aerial imagery (below). Approximate scale is indicated. Transmission line route (approximate) is shown as a dashed white line. Testhole locations are shown as filled x's and reflect corrected GPS coordinates taken in the field. *Image source: U.S.G.S. 1:24,000 and 1:12,000 Alligator Lake quadrangles.*

Testing area 4. Testing area 4 is located on the north of the Stud Mill Road on a high sandy knoll overlooking wetlands along Alligator Stream (Figure 4.1). The testing area is in Great Pond (Plantation 33), Hancock, County, Maine and can be located on the U.S.G.S. 7-1/2 minute (1:24,000 scale) topographic series, Alligator Lake, Maine quadrangle at UTM coordinates Z19N4979796E560582 (NAD 27 meters) and Maine State Plane coordinates N481220E1036812 (Zone Maine East 1801-NAD 83-feet).

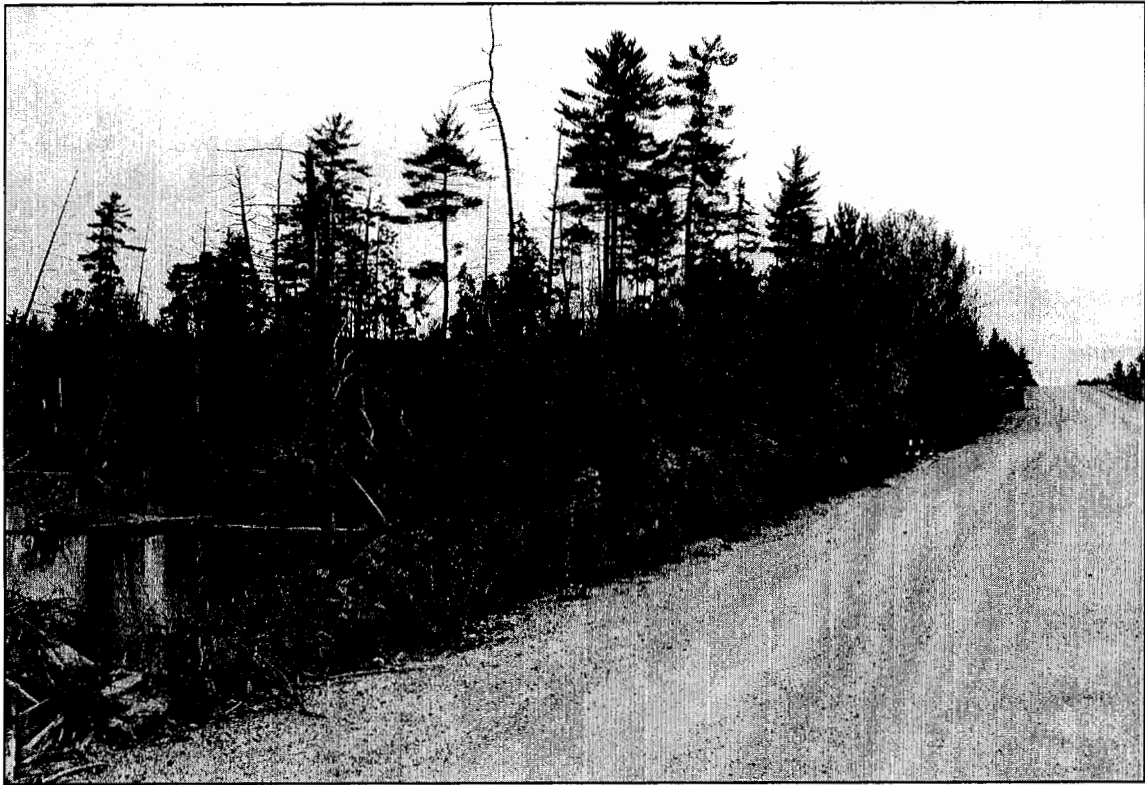
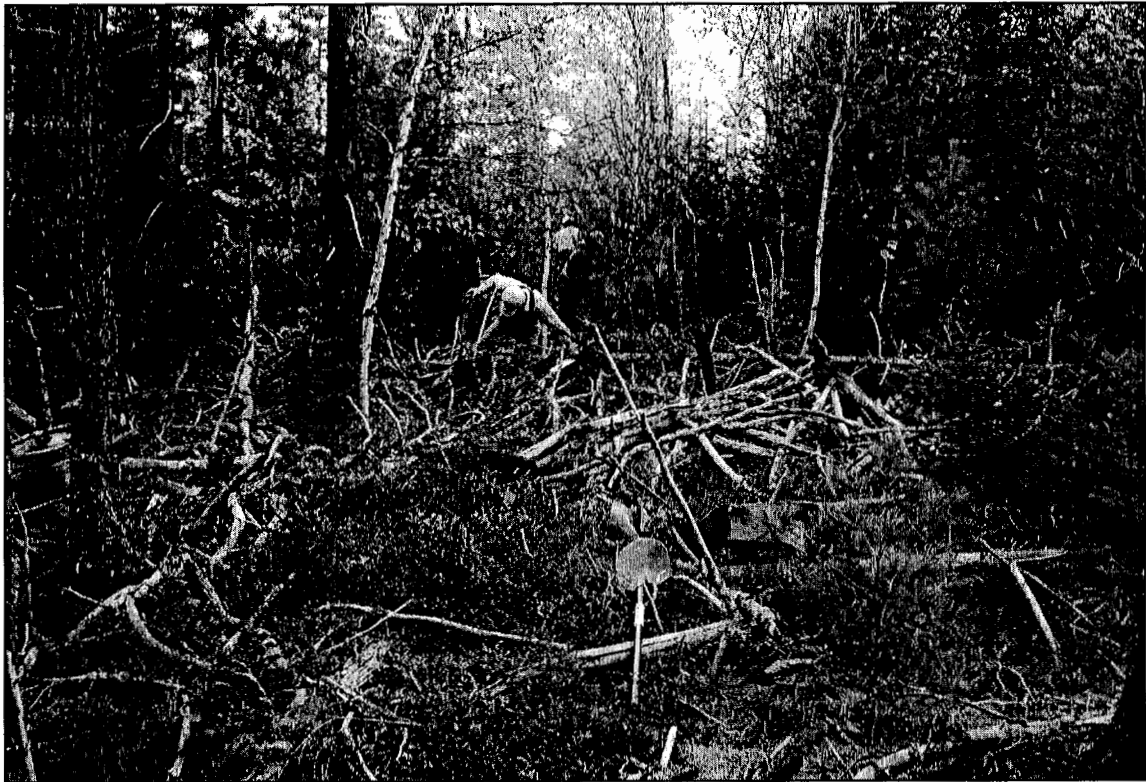
Figure 8.1. Testing Area 8 –Lower Sabao Lake wetland--showing the location of archaeological testholes superimposed on USGS 7.5 minute topographic map (above) and aerial imagery (below). Approximate scale is indicated. Transmission line route (approximate) is shown as a dashed white line. Testhole locations are shown as filled x's and reflect corrected GPS coordinates taken in the field. *Image source: U.S.G.S. 1:24,000 and 1:12,000 Gassabias Lake, Maine quadrangles.*

Testing area 8. Testing area 8 overlooks a wetland area that drains Green Lake and Campbell Lake into Lower Sabao Lake (Figure 8.1). The Project crosses over this wetland area north of the Stud Mill Road in Township 35 MD, Hancock County, Maine. The approximate geographic center of the area tested during Phase I survey can be located on the U.S.G.S. 7-1/2 minute (1:24,000 scale) topographic series, Gassabias Lake, Maine quadrangle at UTM coordinates Z19N4983711E575596 (NAD 27 meters) and Maine State Plane coordinates N488102E1103190 (Zone Maine East 1801-NAD 83-feet).

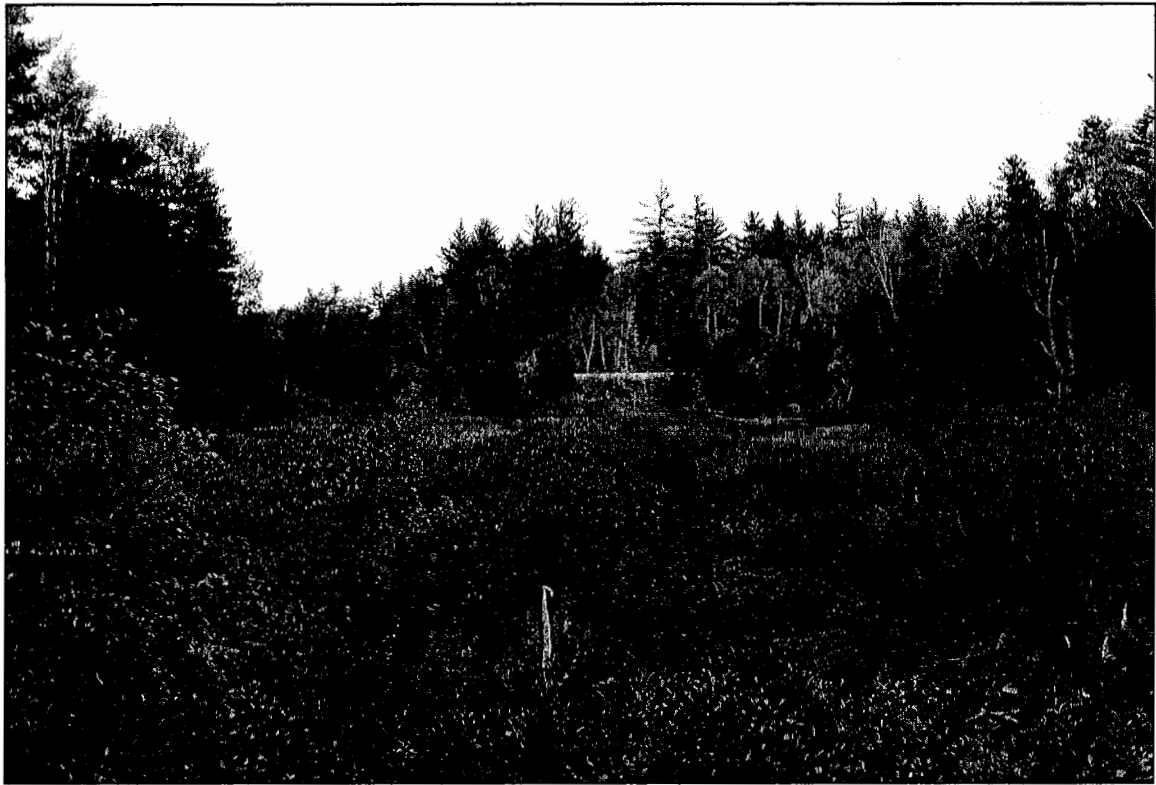
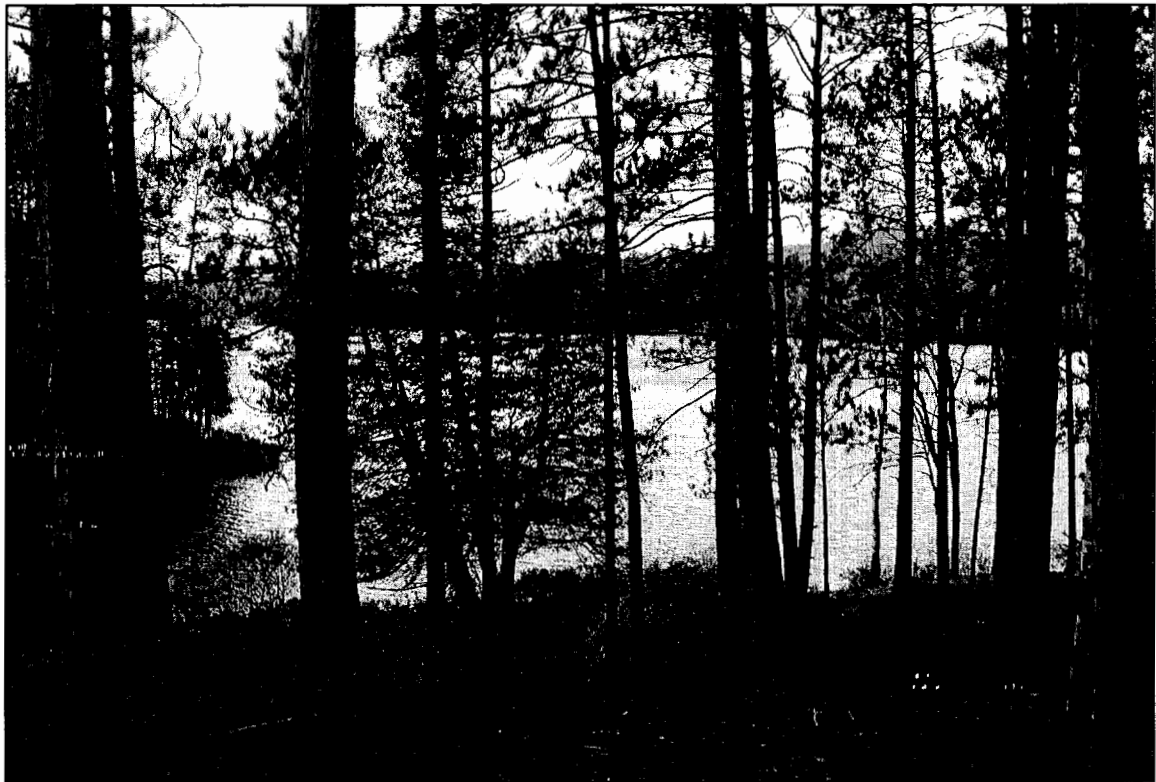
Figure 9.1. Testing Area 9—Lower Sabao Lake Thorofare east and west side—showing the location of archaeological testholes superimposed on USGS 7.5 minute topographic map (above) and aerial imagery (below). Approximate scale is indicated. Transmission line route (approximate) is shown as a dashed white line. Testhole locations are shown as filled x's and reflect corrected GPS coordinates taken in the field. *Image source: U.S.G.S. 1:24,000 and 1:12,000 Gassabias Lake, Maine quadrangles.*

Testing area 9. Testing area 9 is located on the east (TA9E) and west (TA9W) side of the thoroughfare stream that flows from Burnt Land Lake into Lower Sabao Lake (Figure 9.1). The testing area is north of the Stud Mill Road in Township 35 MD, Hancock County, Maine. The center of test area 9E can be located on the U.S.G.S. 7-1/2 minute (1:24,000 scale) topographic series, Gassabias Lake, Maine quadrangle at UTM coordinates Z19N4985088E576403 (NAD 27 meters). The center of test area 9W is at UTM coordinates Z19N4985000E576349 (NAD 27 meters). Maine State Plane coordinates for the Project crossing at Stud Mill Road are N492325E1105871 (Zone Maine East 1801-NAD 83-feet).

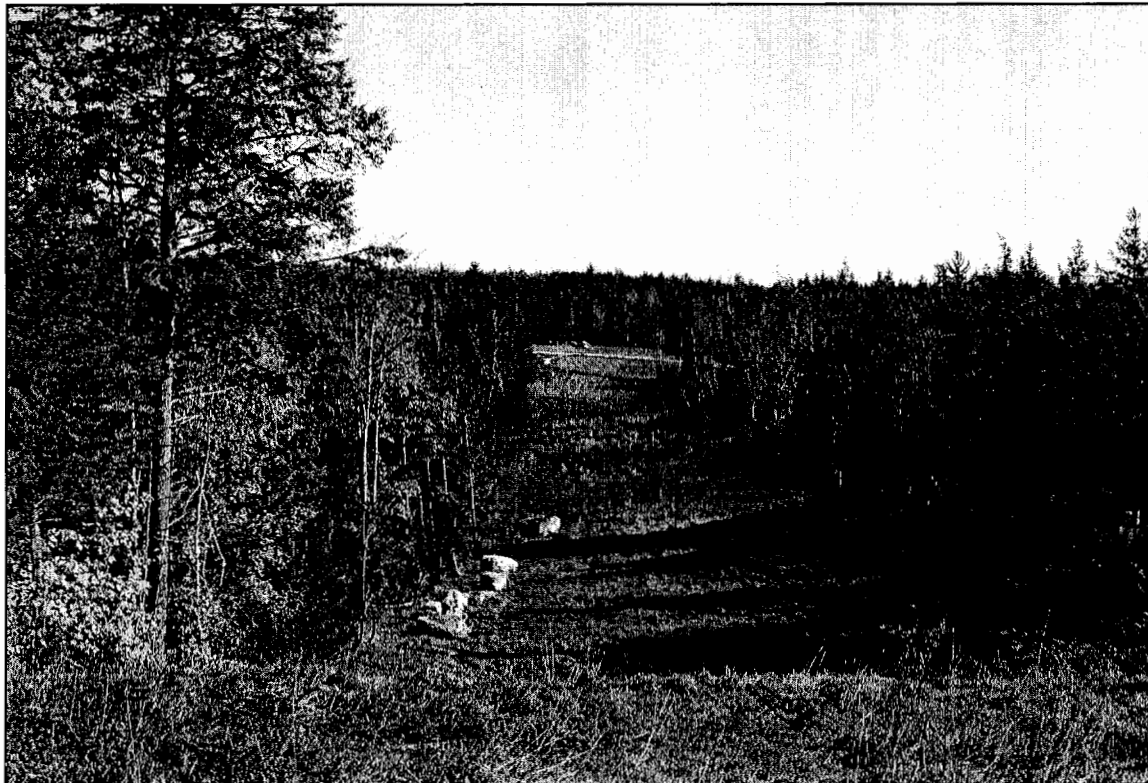
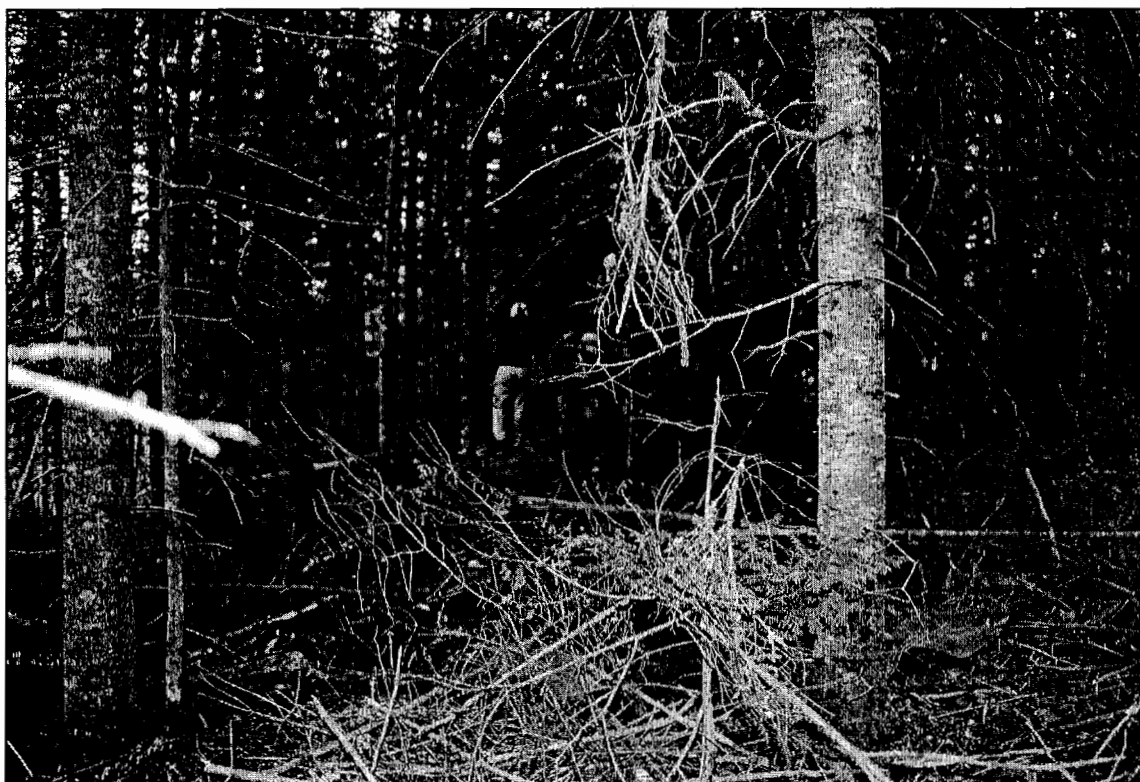
Figure 12.1. Testing Areas 12 –Clifford Stream east and west sides--showing the location of archaeological testholes superimposed on USGS 7.5 minute topographic map (above) and aerial imagery (below). Approximate scale is indicated. Transmission line route (approximate) is shown as a dashed white line. Testhole locations are shown as filled x's and reflect corrected GPS coordinates taken in the field. *Image source: U.S.G.S. 1:24,000 and 1:12,000 Clifford Lake, Maine quadrangles.*

Testing area 12. Testing area 12 is located on both the east and west side of Clifford Stream in Township 27 ED BPP, Washington County, Maine (Figure 12.1). Two testing transects were used to test both sides of the river. Given the steepness of the bedrock-controlled terrain on the western side of Clifford Stream, which drops abruptly into bordering wetlands, the western testing transect is over 100 m west of the stream. The center of Clifford stream, at the point where the Project crosses it, can be located on the U.S.G.S. 7-1/2 minute (1:24,000 scale) topographic series, Clifford Lake, Maine quadrangle at UTM coordinates N4994750E603662 (NAD 27 meters) and Maine State Plane coordinates N523788E1195504 (Zone Maine East 1801-NAD 83-feet).

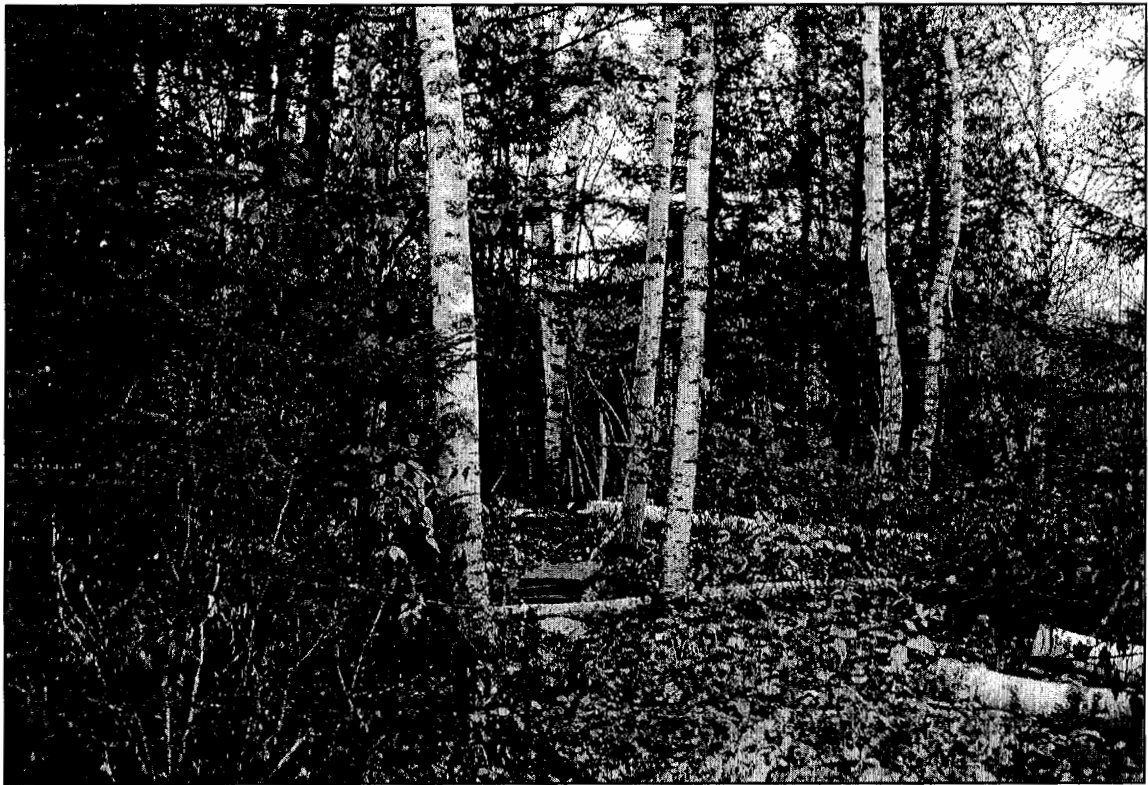
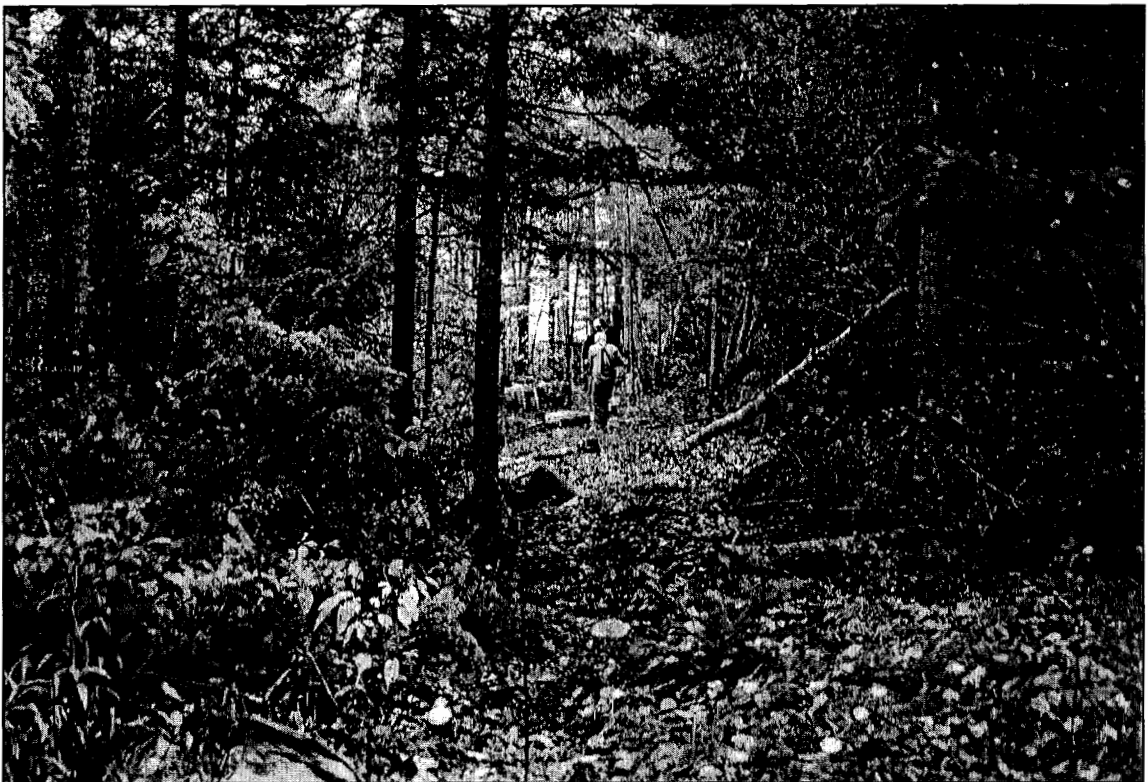
Figure 16.1. Testing Area 16 –Sprague Meadow Brook west side--showing the location of archaeological testholes superimposed on USGS 7.5 minute topographic map (above) and aerial imagery (below). Approximate scale is indicated. Transmission line route (approximate) is shown as a dashed white line. Testhole locations are shown as filled x's and reflect corrected GPS coordinates taken in the field. Image source: U.S.G.S. 1:24,000 and 1:12,000 Woodland, Maine quadrangles.

Testing area 16. Testing area 16 is located on the southwest side of Sprague Meadow Brook in Baileyville, Washington County, Maine (Figure 16.1). It can be located on the U.S.G.S. 7-1/2 minute (1:24,000 scale) topographic series, Woodland, Maine quadrangle at UTM coordinates N5006925E621856 (NAD 27 meters) and Maine State Plane coordinates N563339E1255468 (Zone Maine East 1801-NAD 83-feet).

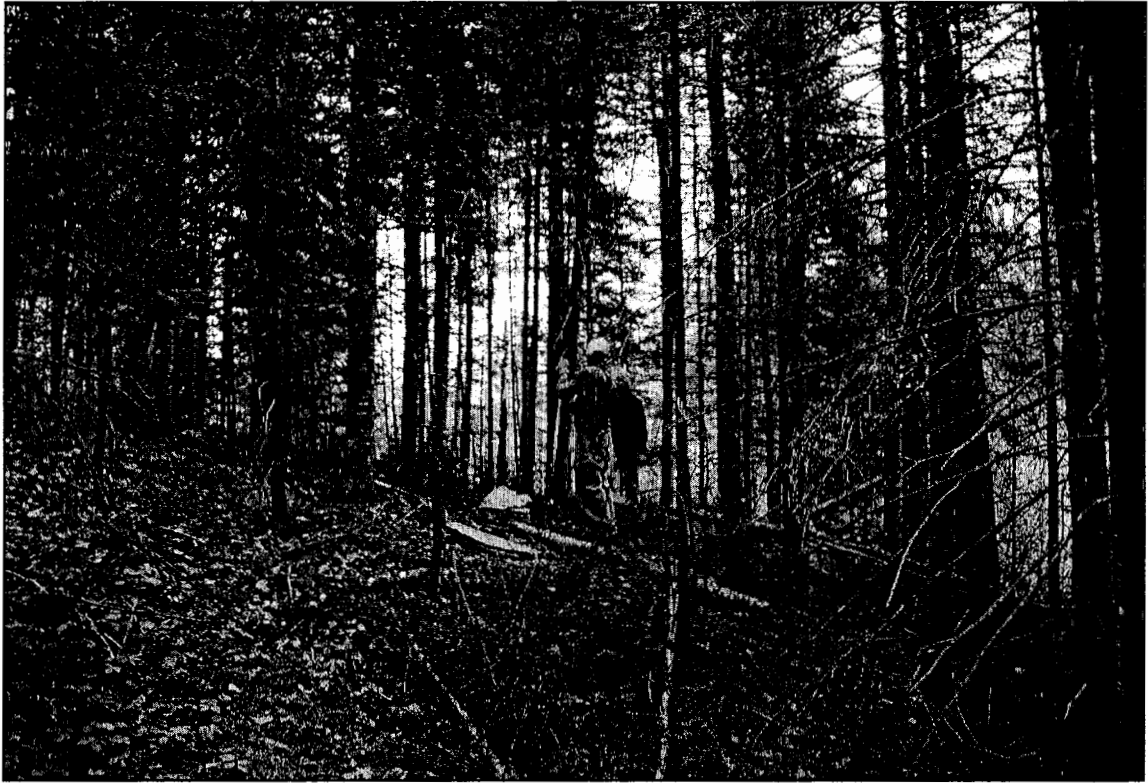
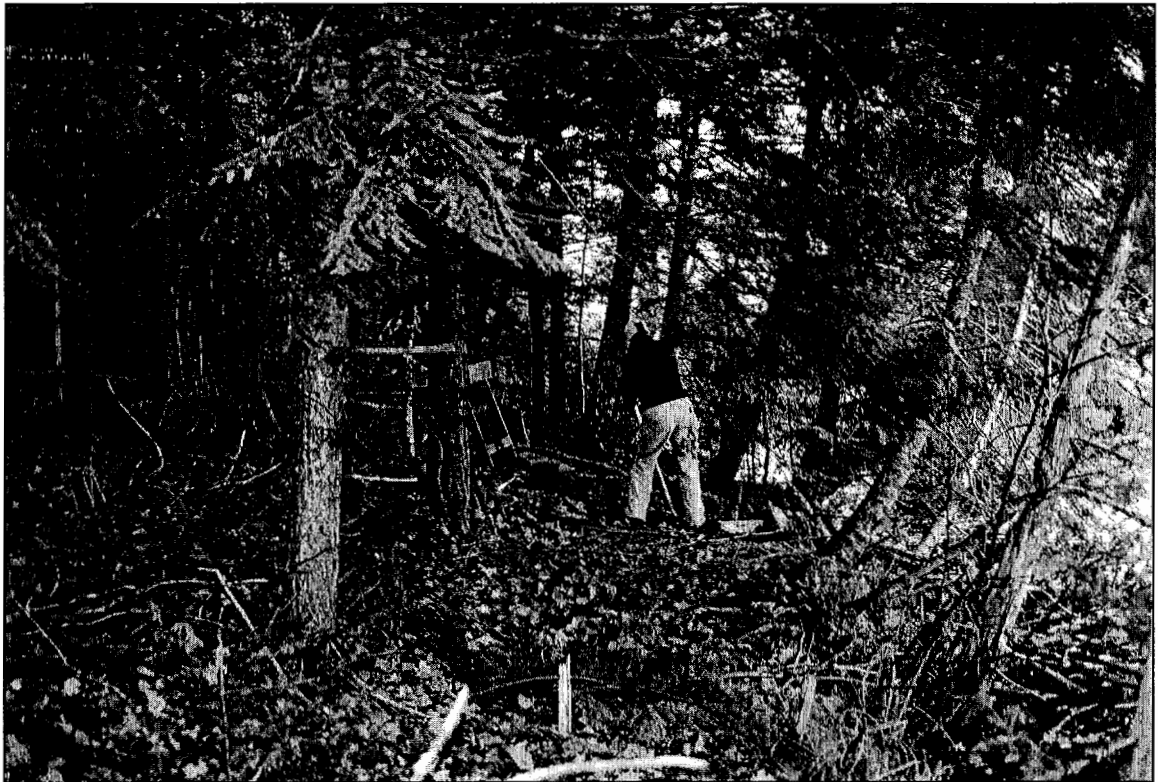
Figure 18.1. Testing Area 18—Little Musquash Lake--showing the location of archaeological testholes superimposed on USGS 7.5 minute topographic map (above) and aerial imagery (below). Approximate scale is indicated. Transmission line route (approximate) is shown as a dashed white line. Testhole locations are shown as filled x's and reflect corrected GPS coordinates taken in the field. *Image source: U.S.G.S. 1:24,000 and 1:12,000 Woodland, Maine quadrangles.*

Testing area 18. Testing area 18 is located south of Little Musquash Lake in Township 37 MD BPP, Washington County, Maine (Figure 18.1). The UTM coordinates for the site are N4989008E593393 (NAD 27 meters), which can be located on the U.S.G.S. 7-1/2 minute (1:24,000 scale) topographic series, Monroe Lake, Maine quadrangle. Maine State Plane coordinates are N505118E1161724 (Zone Maine East 1801-NAD 83-feet).

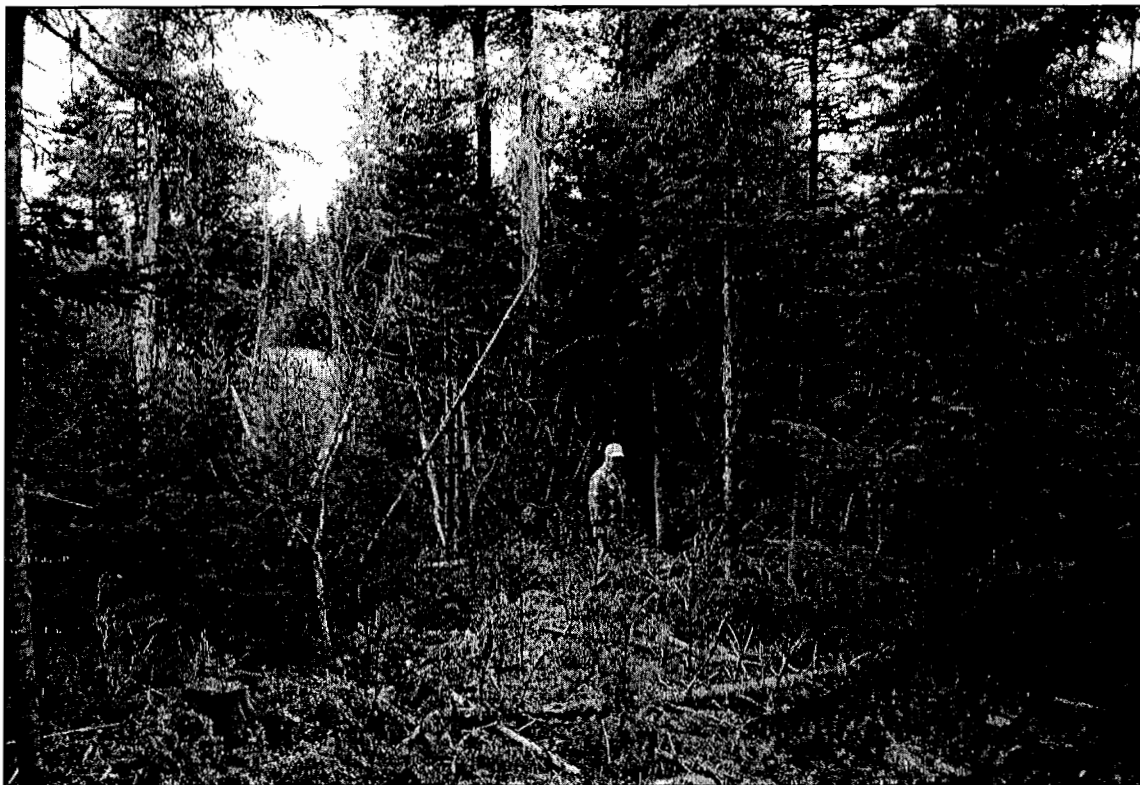
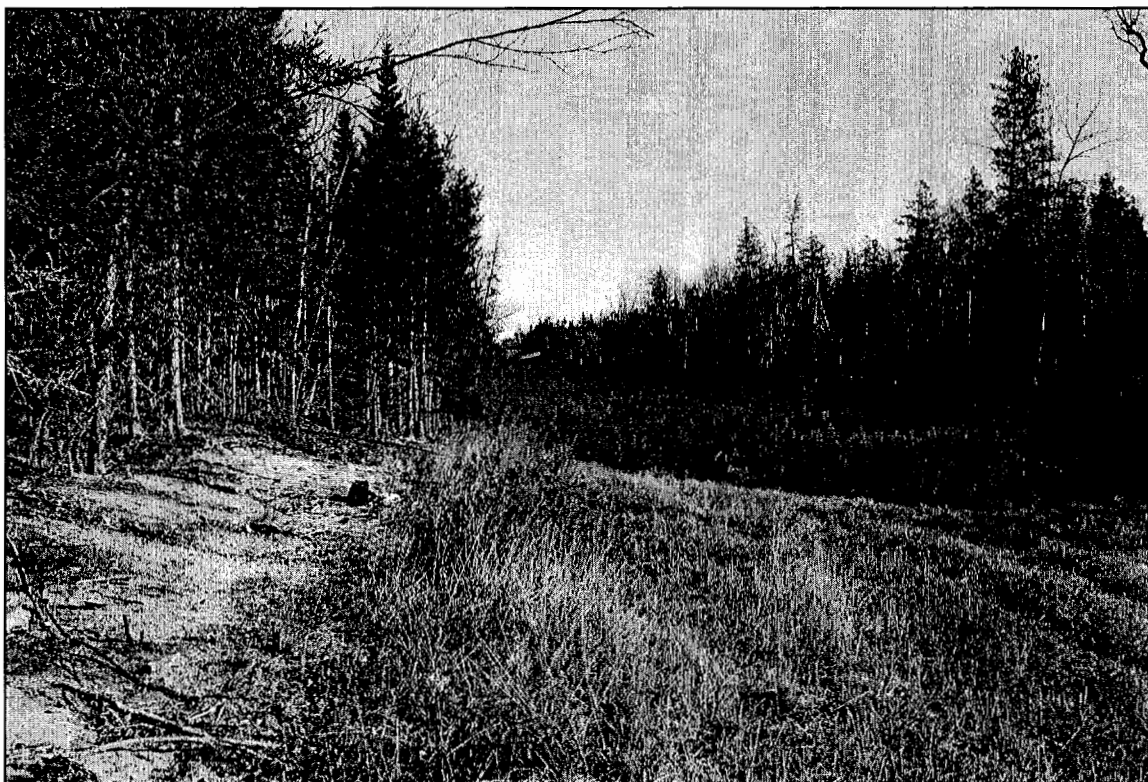
Figure 20.1. Historic Testing Area 2—Myra Camps—showing the location of archaeological testholes superimposed on USGS 7.5 minute topographic map (above) and aerial imagery (below). Approximate scale is indicated. Transmission line route (approximate) is shown as a dashed white line. Testhole locations are shown as filled x's and reflect corrected GPS coordinates taken in the field. *Image source: U.S.G.S. 1:24,000 and 1:12,000 The Horseback, Maine quadrangles.*

Historic testing area 2. Historic testing area 2 is located in Myra (T32 MD), Hancock, County, Maine (Figure 20.1). The location is 25 m east of Ten Hill Road in Myra, roughly 200 m north of the intersection of Ten Hill Road and the Stud Mill Road. The proposed transmission line route will swing wide north of the Stud Mill Road in this location to avoid a series camps that border the Stud Mill Road to the east. The area tested can be located on the U.S.G.S. 7-1/2 minute (1:24,000 scale) topographic

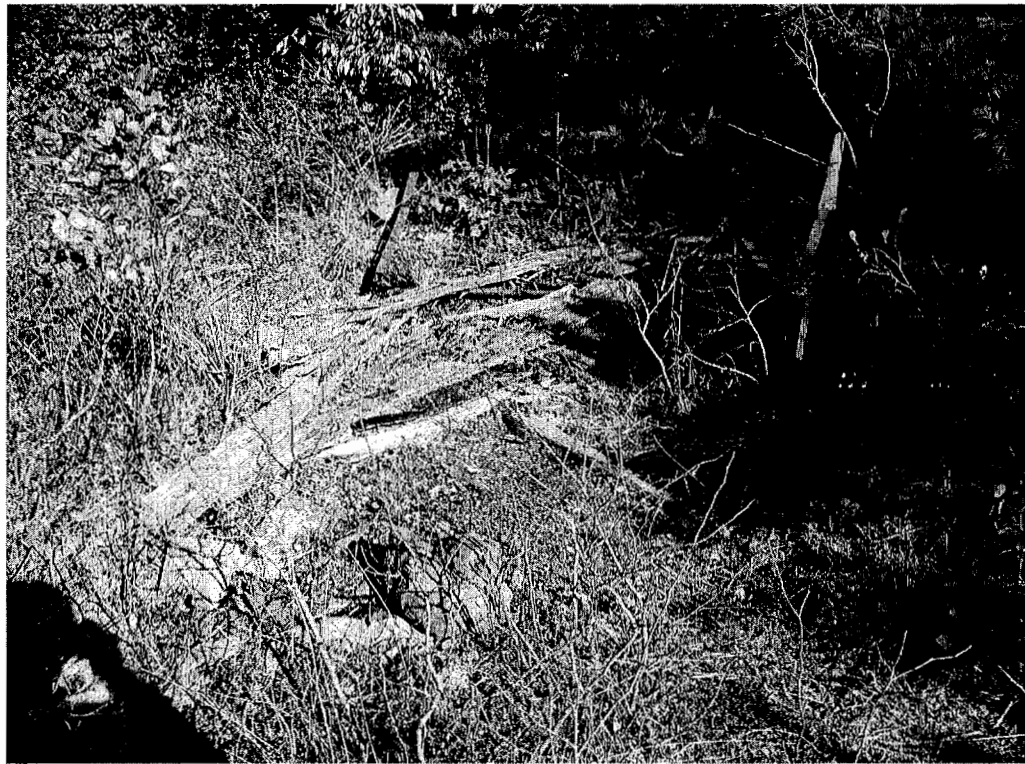
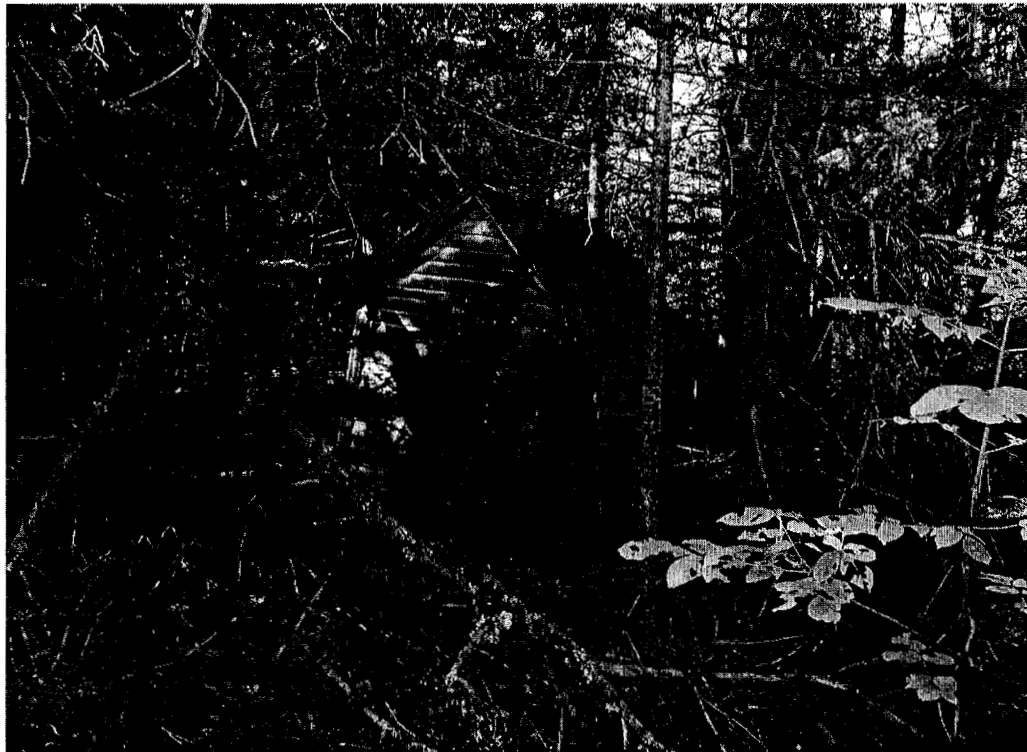
Plate 15a (top). Stud Mill Road Farmstead— View southeast of east and south wall of foundation. Note: south wall is partially collapsed into cellarhole.

Plate 15b (bottom). Stud Mill Road Farmstead— View northeast of east and north wall of foundation.

The cellarhole measures approximately 8 m (26 ft) by 8 m (26 ft), with the northeast corner in a good state of preservation. Plate 15a shows the preserved section of the east wall, which stands 1.3 m (4 ft) tall. Stones are small fieldstone boulders and unmortared. The north and west walls have partially slumped in, while the southeast corner has been pushed into the cellarhole.
